POPPLETON HISTORIC STUDY

B-2723  
MAG#0427235504

<u>Block</u>	<u>Lot</u>	<u>Address</u>
249	43-32	1225-1247 W. Lombard Street

B-2723  
1225-1247 W. Lombard Street (1225 demolished)  
Block 0249, Lots 032-043  
Baltimore City  
Baltimore West Quad

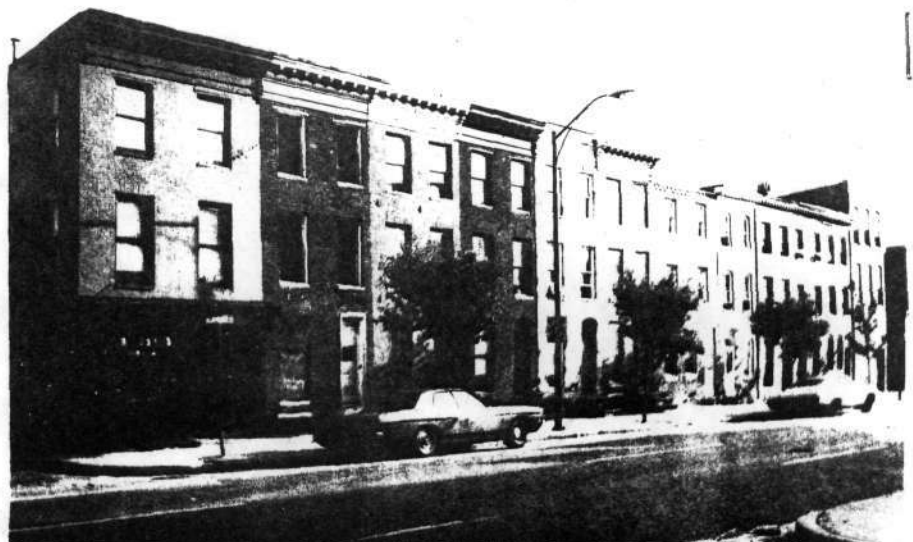
Number 1225 has nice original shop front, but front wall is buckling and cracking. Good facades on 1225-1235 except that 1233 has been spoiled by formstone and cornice removal. Numbers 1239-1245 are smaller, less pretentious houses of same date; Number 1237 has a new front and no cornice. Number 1247 has been altered and formstoned heavily. Reasonably well cared for row; 1227 should be rehabilitated.

Number 1227 is vacant.
